# **Planar View of Structural Degradation in GaN HEMT:** *Voltage, Time and Temperature Dependence*

Jungwoo Joh<sup>1</sup>, Prashanth Makaram<sup>2</sup>  
Carl V. Thompson<sup>2</sup> and Jesús A. del Alamo<sup>1</sup>

<sup>1</sup>Microsystems Technology Laboratories, <sup>2</sup>Material Processing Center  
Massachusetts Institute of Technology, Cambridge, MA, USA

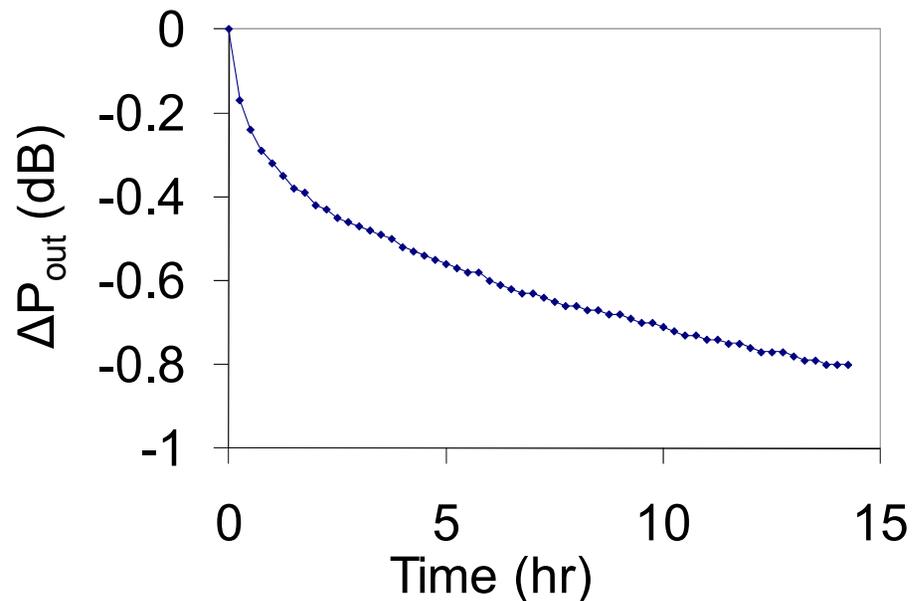
## RF stress

10 GHz,  $V_D=28$  V

$I_{DQ}=150$  mA/mm

$P_{in}=23$  dBm

$P_{out}=33.7$  dBm

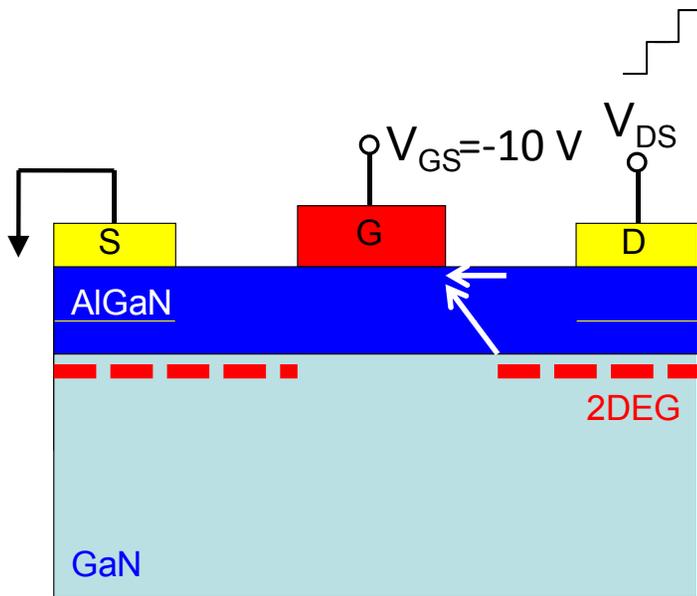
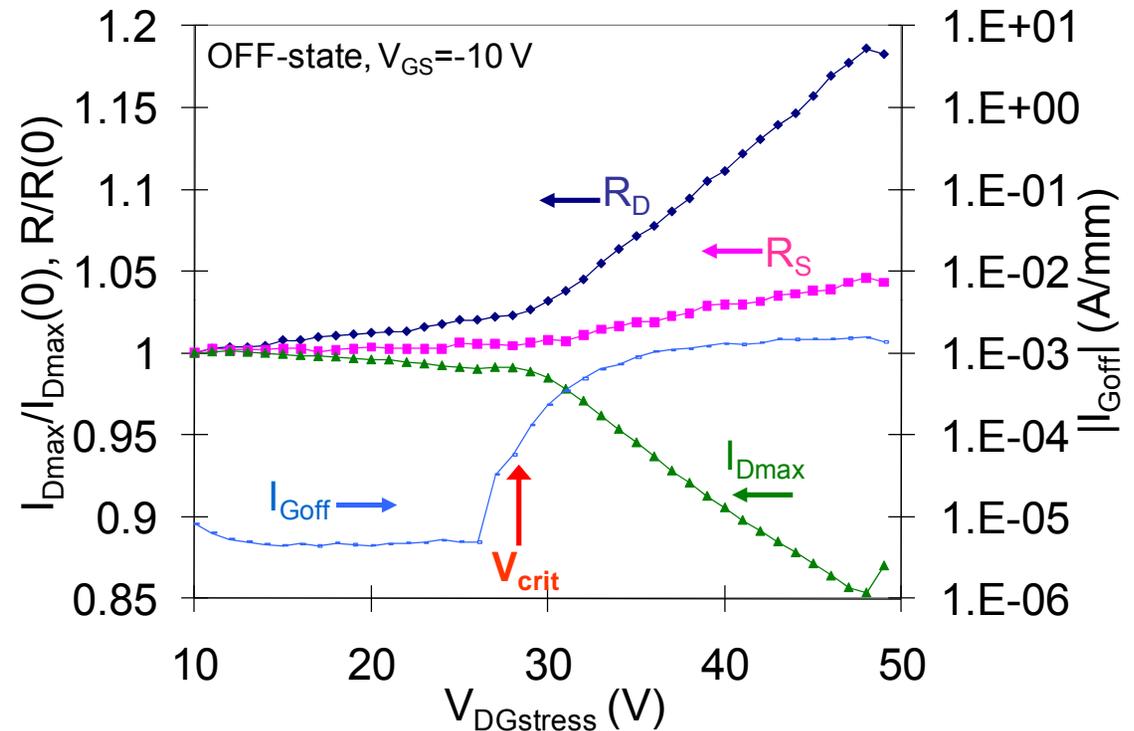
Joh, EDL 2008

$I_{Dmax}$ :  $V_{DS}=5$  V,  $V_{GS}=2$  V     $I_{Goff}$ :  $V_{DS}=0.1$  V,  $V_{GS}=-5$  V

$I_D$ ,  $R_D$ , and  $I_G$  start to degrade beyond **critical voltage ( $V_{crit}$ )**  
(+ trapping behavior – current collapse)

Common physical origin in  $I_D$  and  $I_G$  degradation

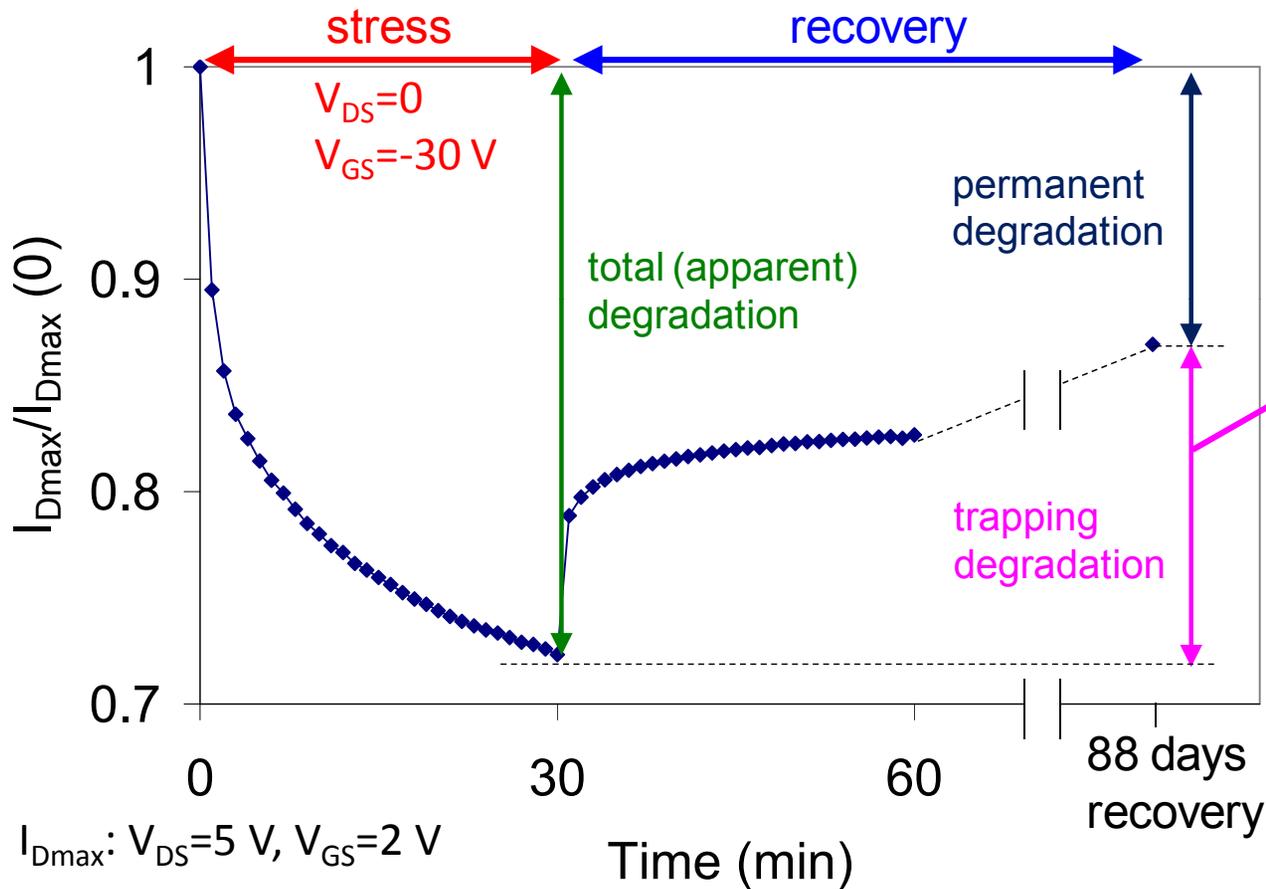
## Two components:

- Native traps
- Stress-induced traps

Separated by  
**current collapse**  
 measurements:  
 1s  $V_{DS}=0, V_{GS}=-10\text{V}$   
*diagnostic pulse*

13 % permanent degradation + 15 % trapping degradation

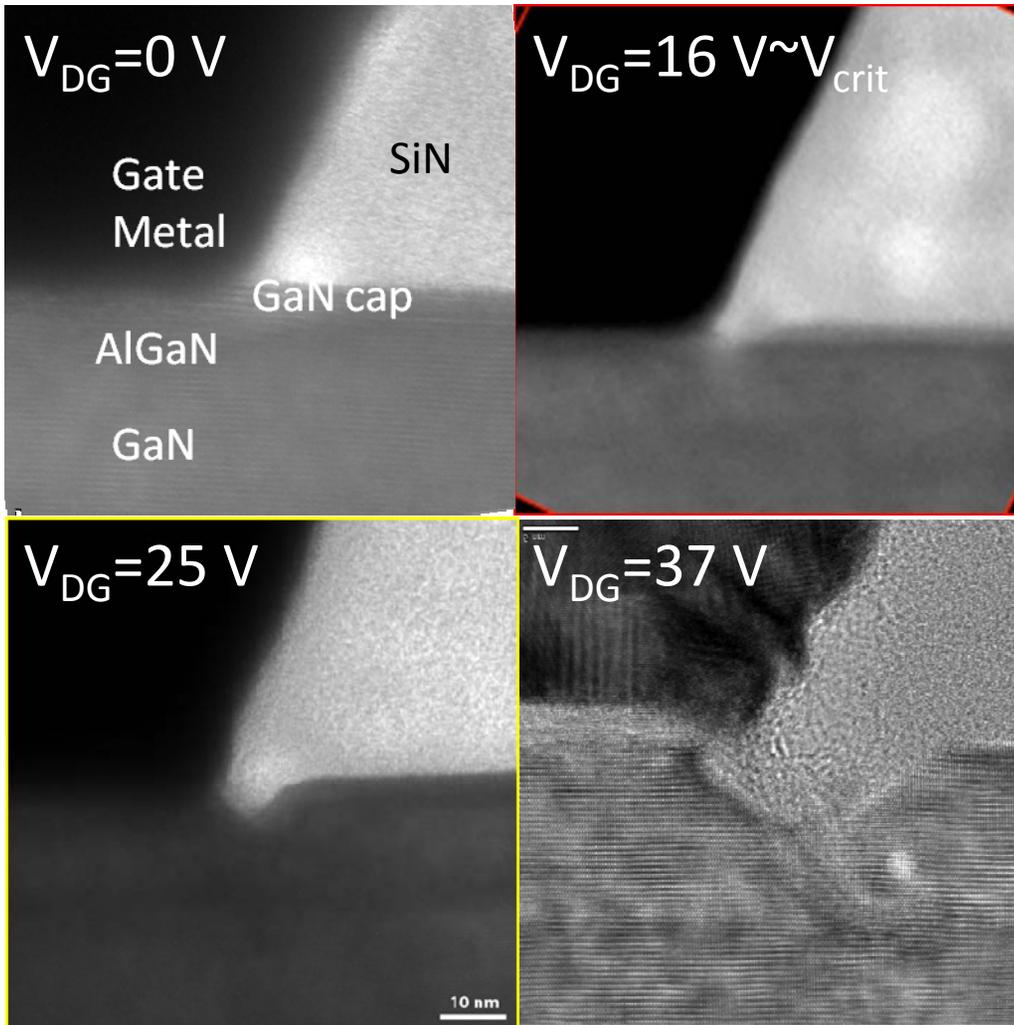
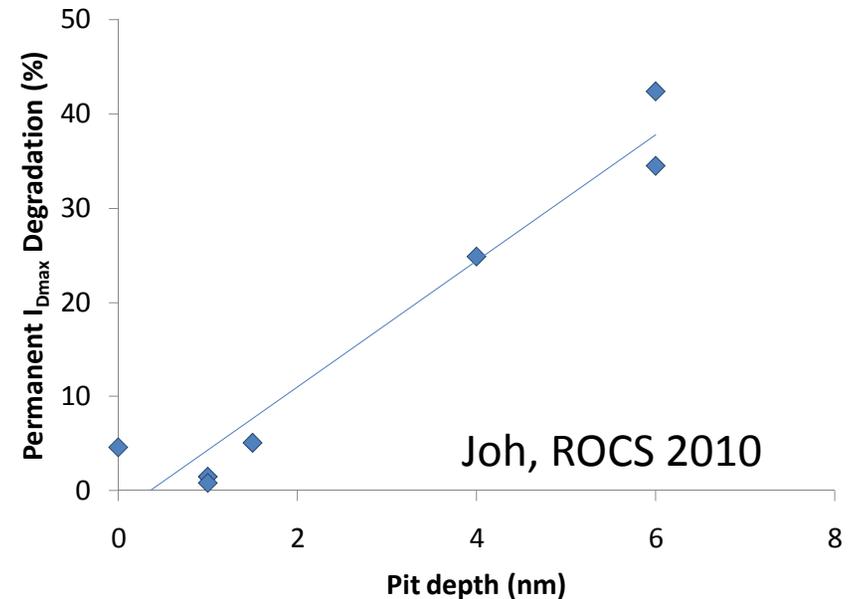
Initial **dimple** followed by deeper **pit** and **crack**.  
**Good correlation** between pit depth and  $I_{Dmax}$  degradation

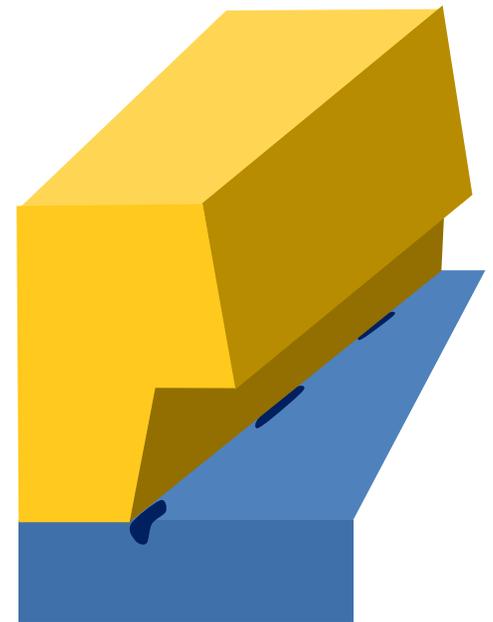
- Limitations of *TEM*:
  - Costly
  - Extremely local
- **This work:** (details in Makaram, APL 2010)
  - Removal of SiN passivation and gate
    - SiN passivation: HF etch
    - Contact and gate metals: aqua regia
    - Surface cleaning: piranha solution
  - **Plan view imaging** through *SEM* and *AFM*

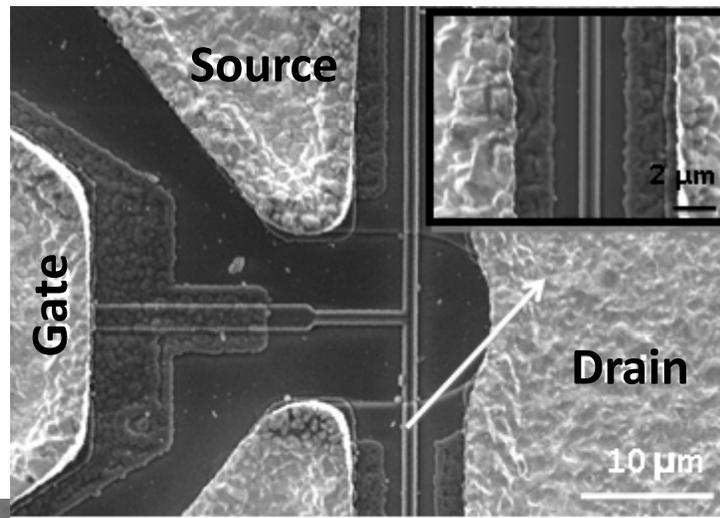
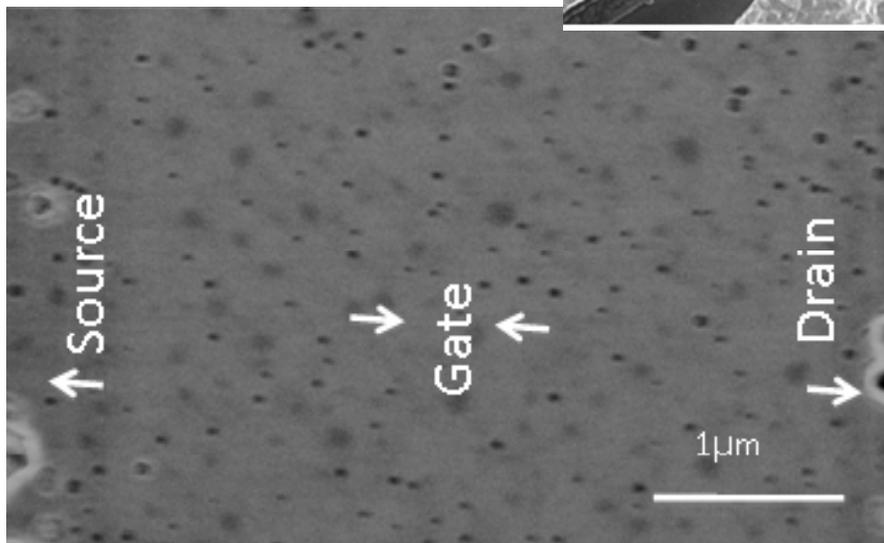
Unstressed (high T storage)

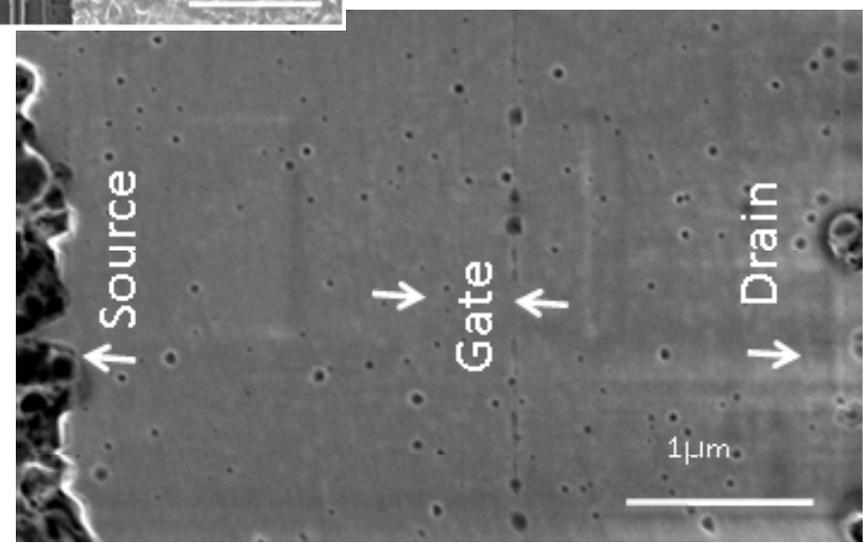
Stressed ( $> V_{\text{crit}}$ )

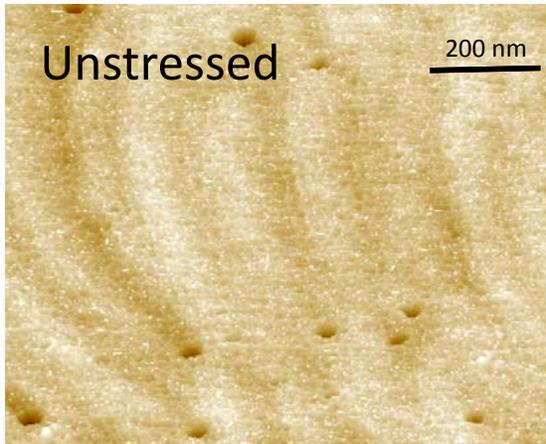
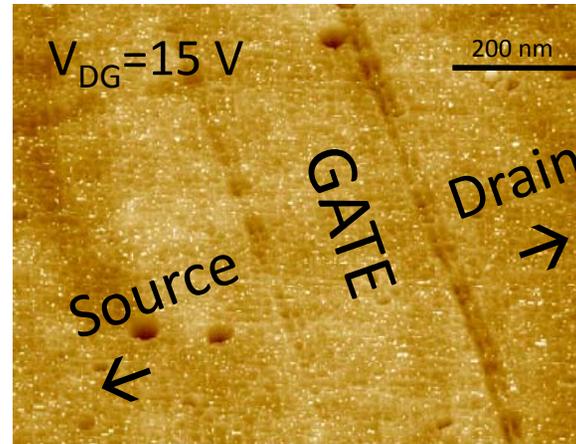
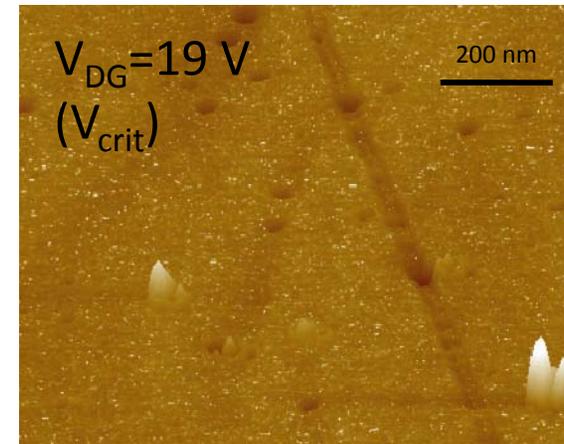
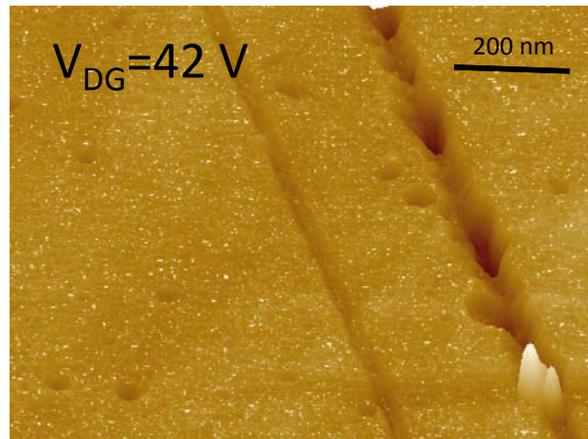
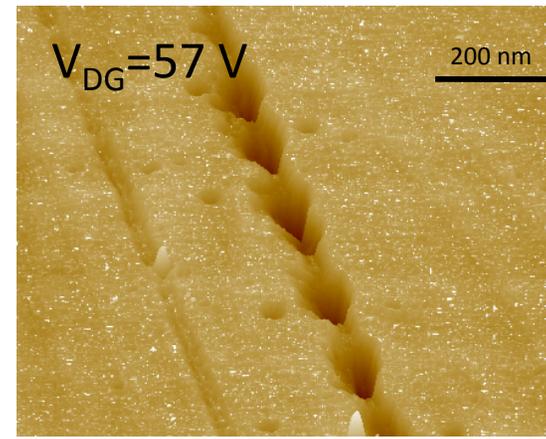
OFF-state step-stress,  $V_{GS} = -7$  V,  $T_{base} = 150$  °C

Initial continuous **groove** formation  
Deeper **pit** formation along the groove

- OFF-state step stress:
  - $V_{GS} = -7$  V
  - $V_{DS}$  stepped from 5 to 8, 12, 35, 50 V (1 min/1 V step)
  - $T_{base} = 150$  °C
- Detailed device characterization:
  - DC device parameters:  $I_{Dmax}$ ,  $R_S$ ,  $R_D$ ,  $V_T$ ...
  - Trap characterization: current collapse
- Removal of passivation and gate metal
- SEM and AFM plan view imaging

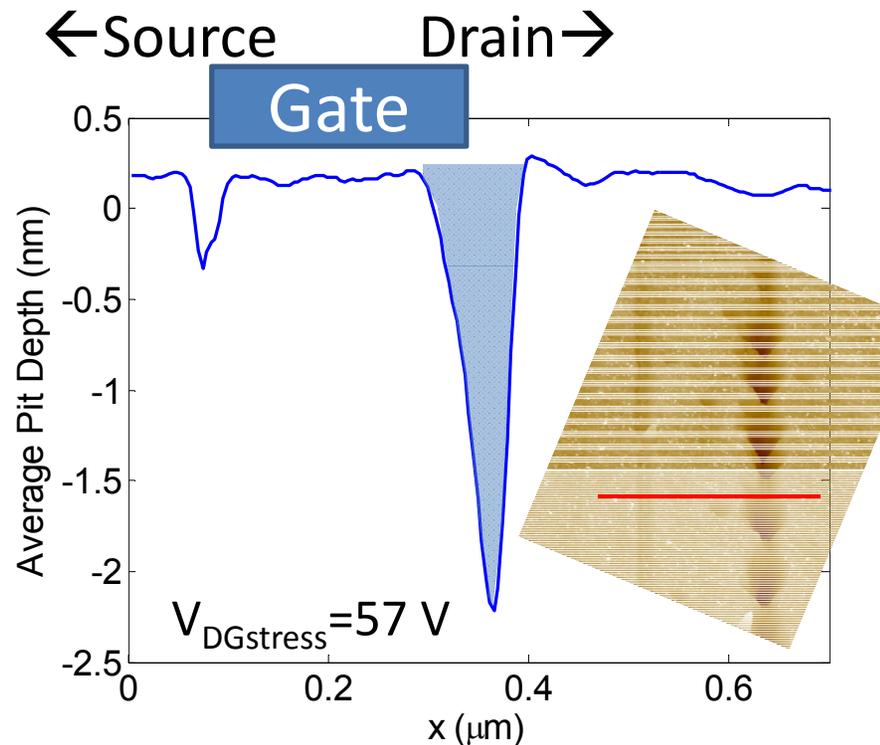
Cross section averaged over  $1\ \mu\text{m}$ .

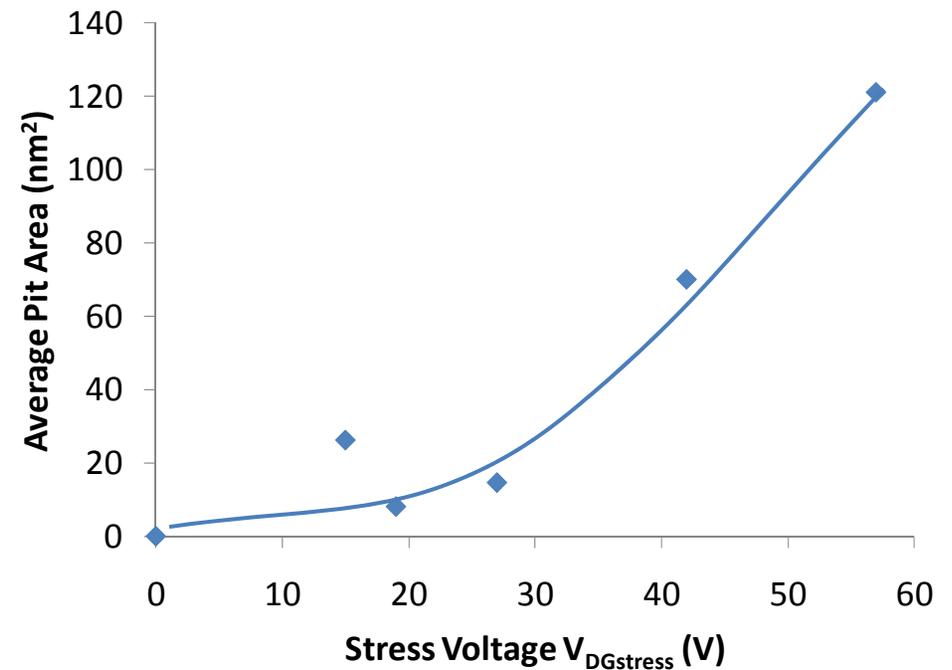
Pit formation is **voltage accelerated**.

Drain side pit area also shows **critical behavior**.

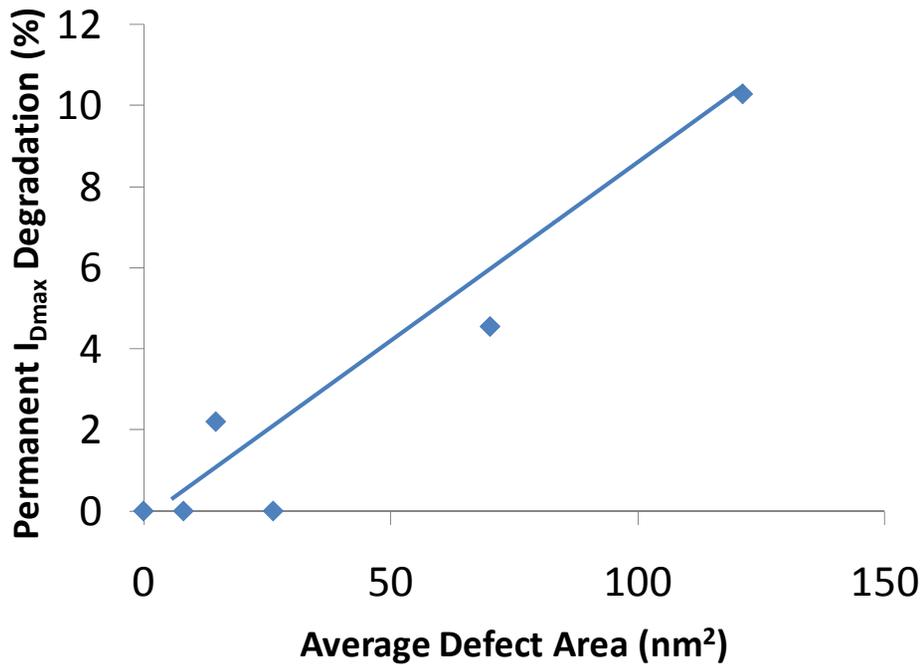
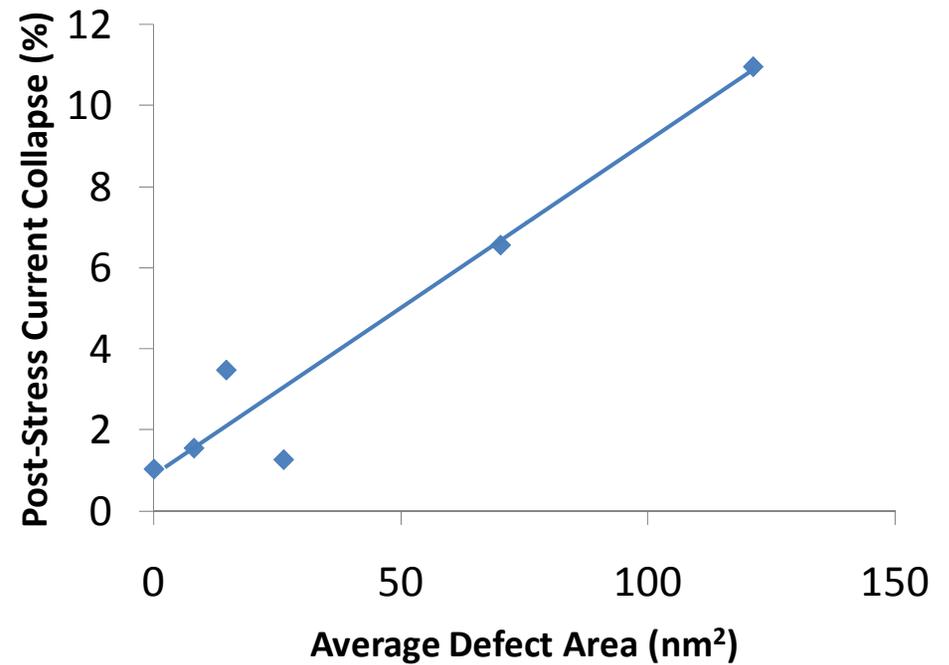
Good correlation between electrical degradation and pit area

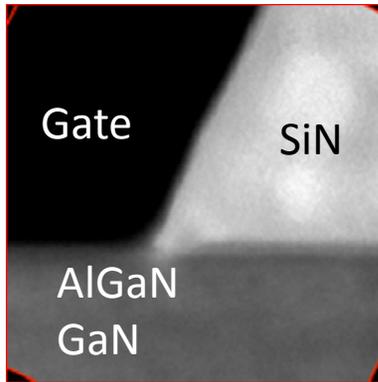
1. Below and around  $V_{crit}$ :  
**Groove formation** in **GaN cap**

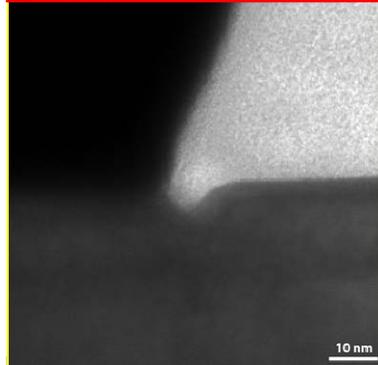
2. Beyond  $V_{crit}$ :  
**Pit formation** in **AlGaN barrier**

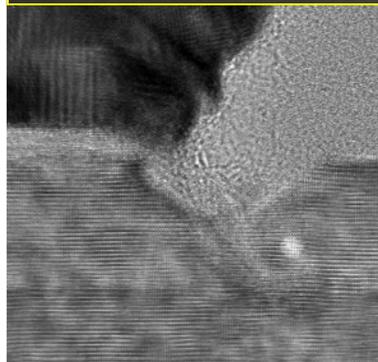
3. Pit growth (to AlGaN/GaN interface) and merge

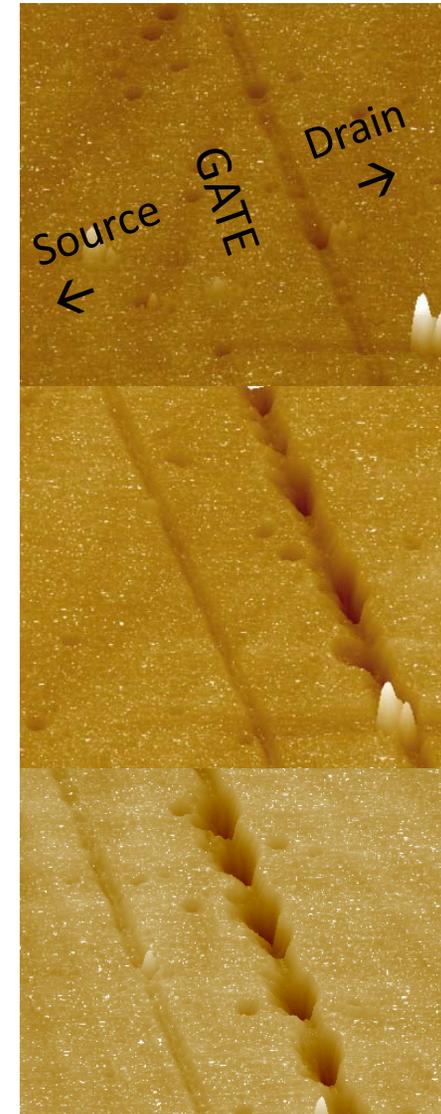
Plan-view

**Consistent** behavior  
**Complimentary** techniques

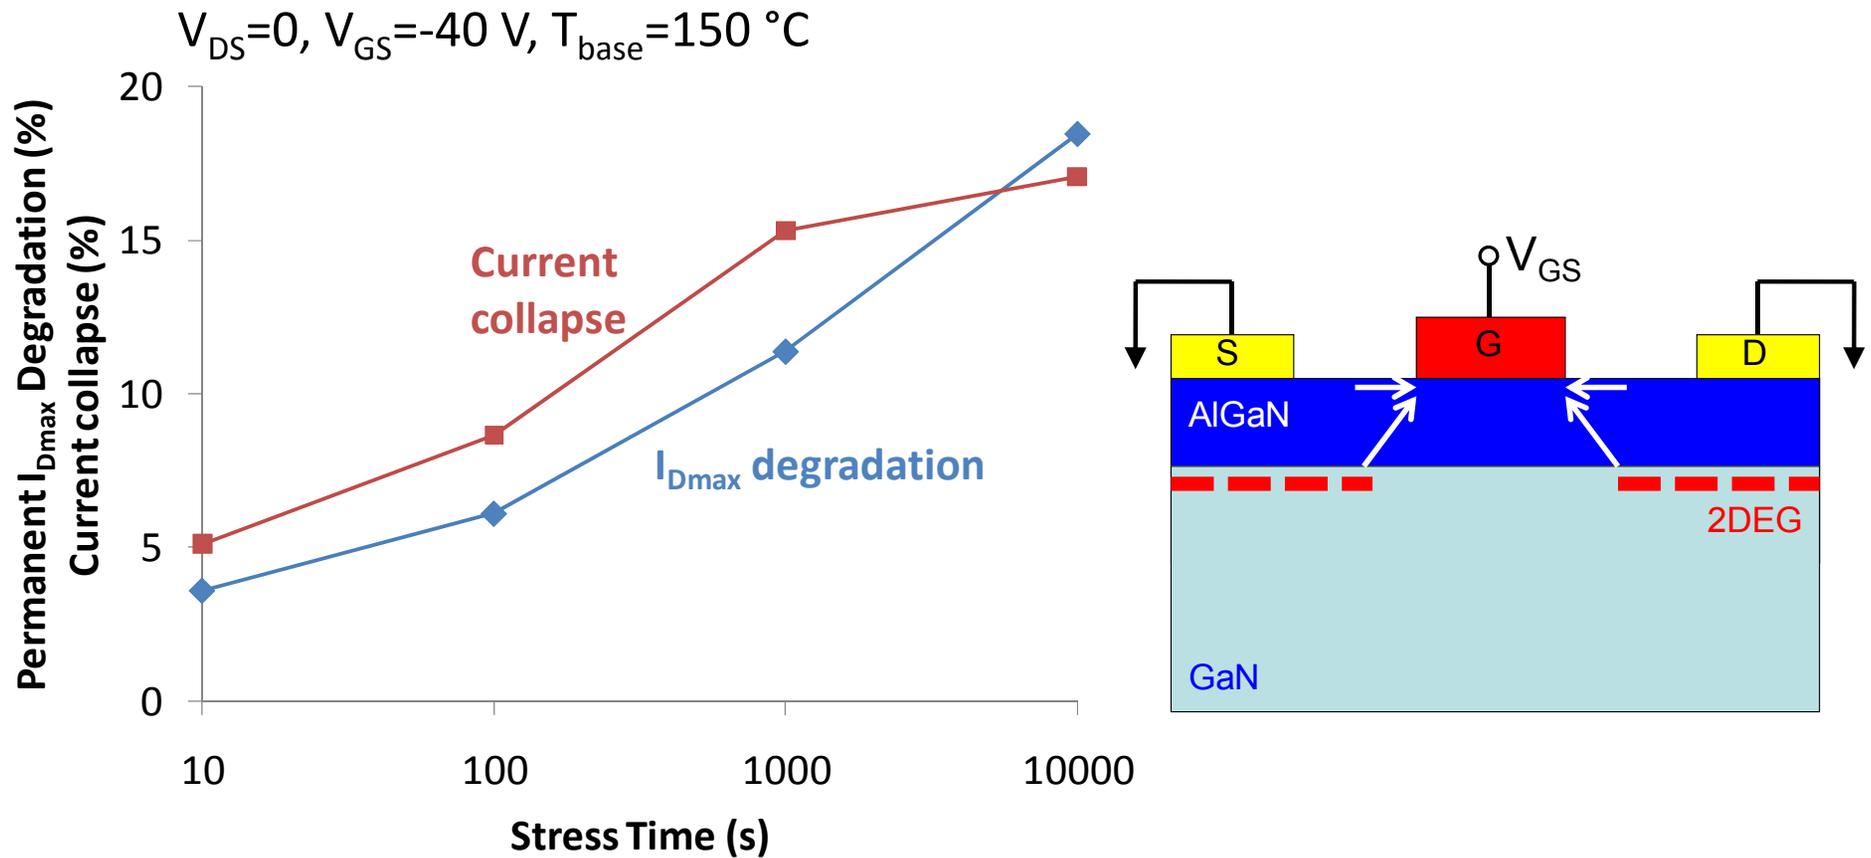
Current collapse tends to saturate.  
Permanent degradation keeps increasing.

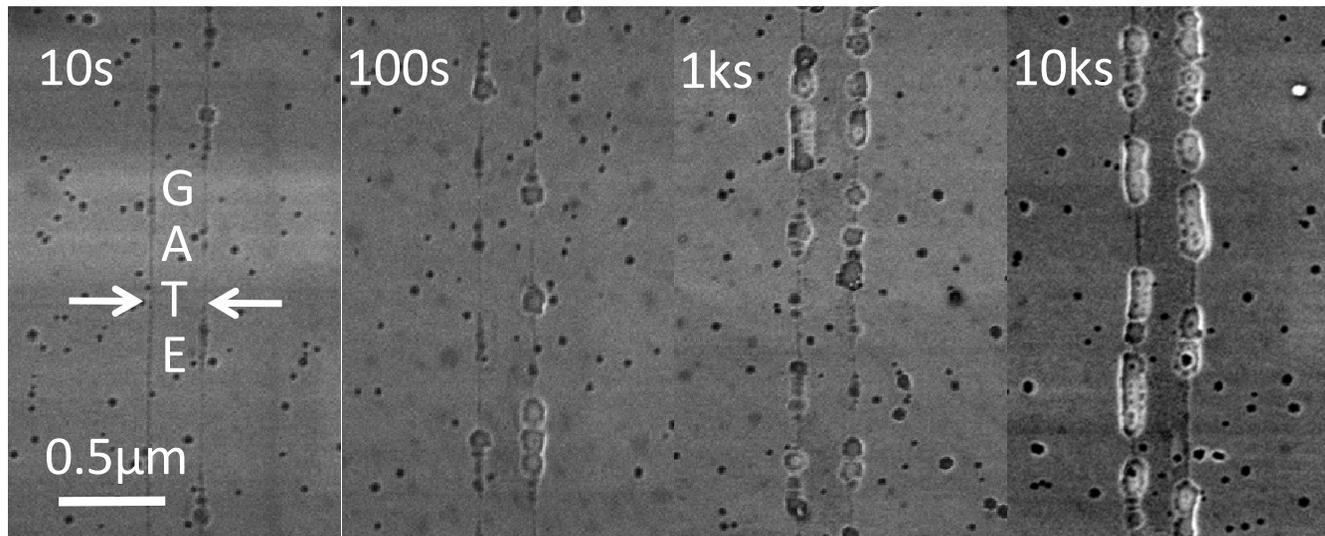
$V_{DS}=0$ ,  $V_{GS}=-40$  V,  $T_{base}=150$  °C

Very **fast groove formation** (10 s) on both sides.  
Pit density/size increase with time.

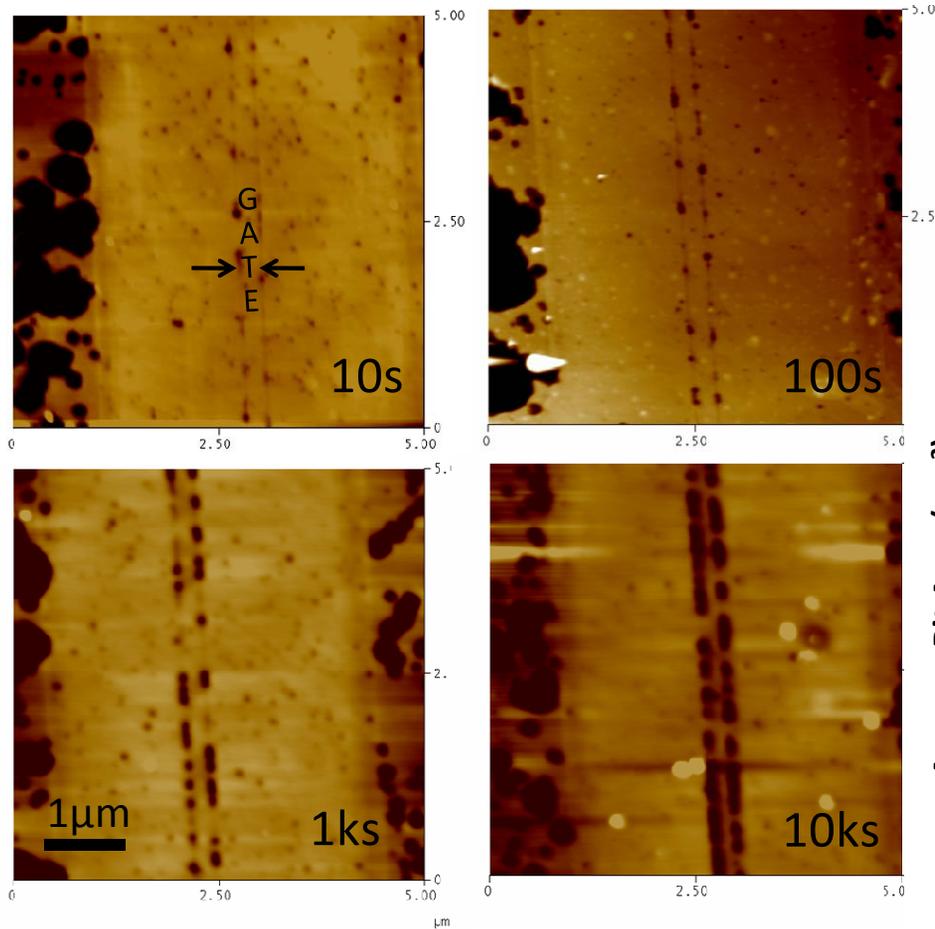
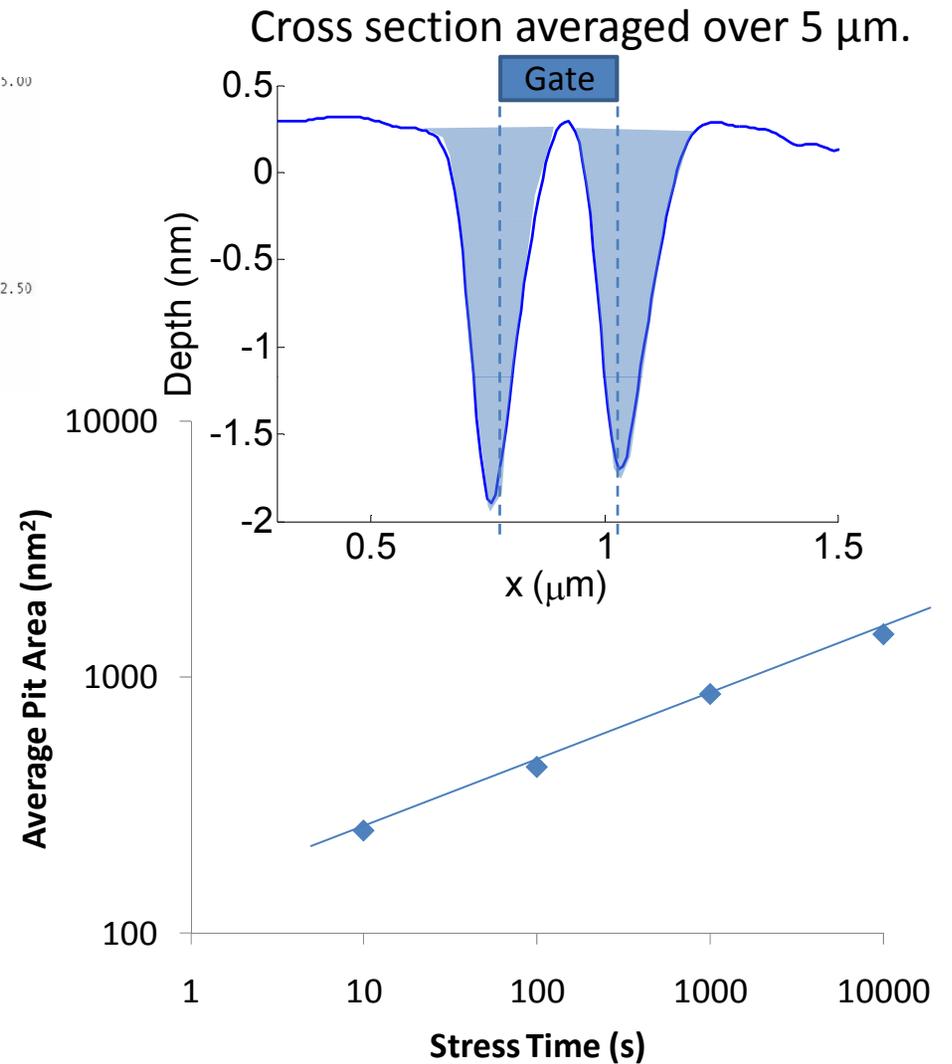
Average pit area (~pit volume)  $\sim t^{1/4}$

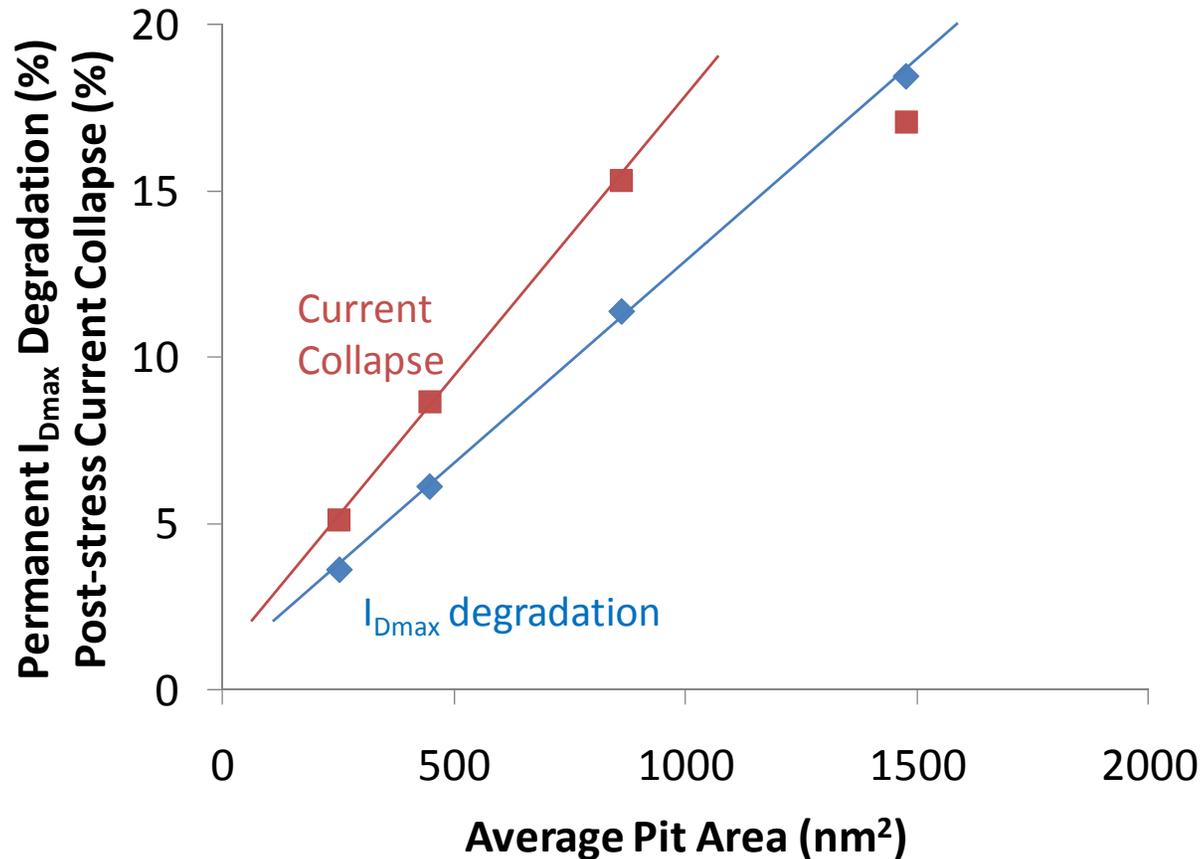
Good correlation between electrical and structural degradation.

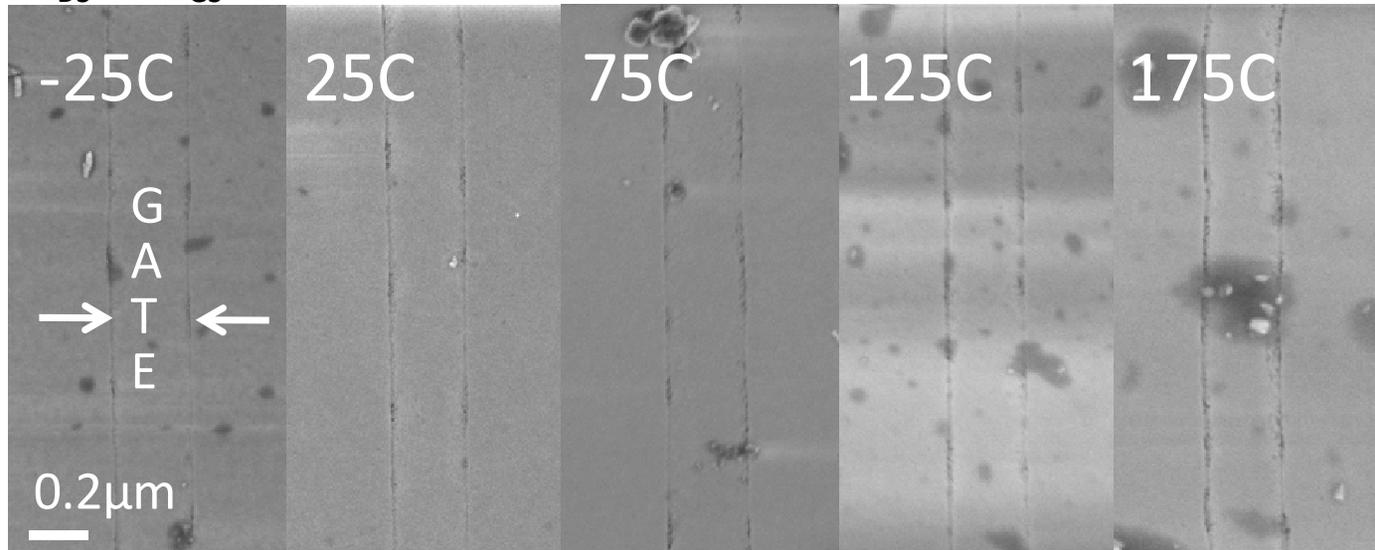
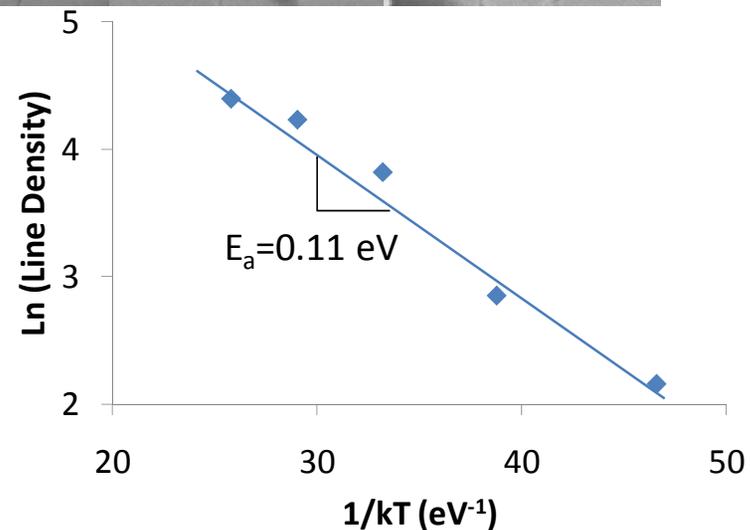
$V_{DS}=0$ ,  $V_{GS}=-10$  to  $-50$  V (1min/1V step)

Linear defect density  
( $\sim 1/\text{degradation rate}$ ) is  
**thermally activated** with  
 $E_a \sim 0.11$  eV
